Battery Maritime Building Flood Protection Alignments Memo

Financial District and Seaport Climate Resilience Plan
November 2024

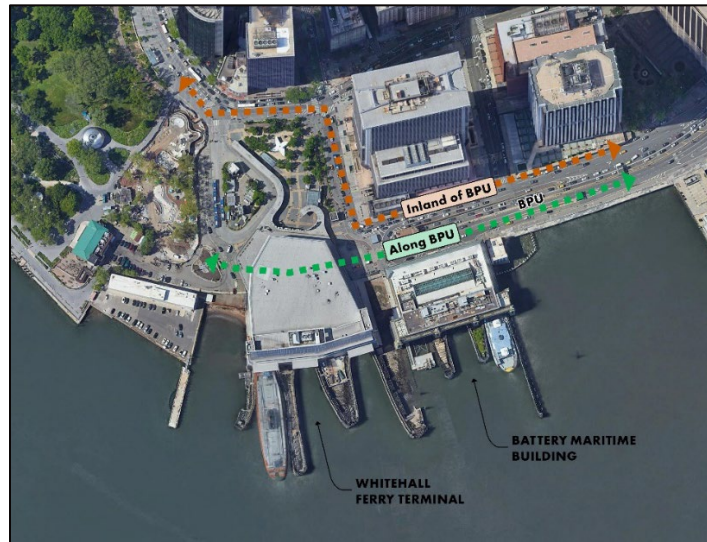
Figure 3: On-land alignment options between the southern tie-in and the BMB

An option inland of the BPU would aim to avoid direct impacts to both the Whitehall Ferry Terminal and the BMB. To achieve this, the coastal defense system would have to be integrated with adjacent building podiums north of South Street and across through Peter Minuit Plaza. With several subway tunnels (4/5 train, R/W train), the South Ferry Loop, and subway station (Whitehall Station) underneath the plaza, this option would encounter significant technical obstacles underground. An overview of the subsurface infrastructure in this area is shown in Figure 4.

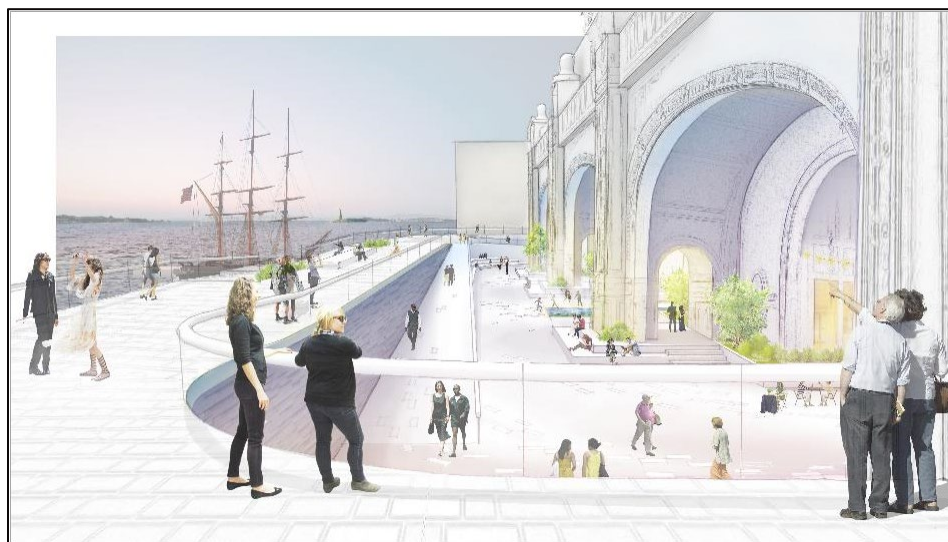
Figure 9: Flood defense alignment and esplanade outboard of the BMB (draft)

esplanade with higher accessibility and multiple opportunities for public use as shown in Figure 9. This option also allows the subway tunnels to be crossed with shorter spans and better access, improving constructability. As the FiDi-Seaport Plan advances towards implementation, historic impacts will be evaluated and coordinated with relevant agencies. Note that the design of outboard floodwall and how it interacts with the building's seaward façade is still under development, in addition to the waterside esplanade and platforms.

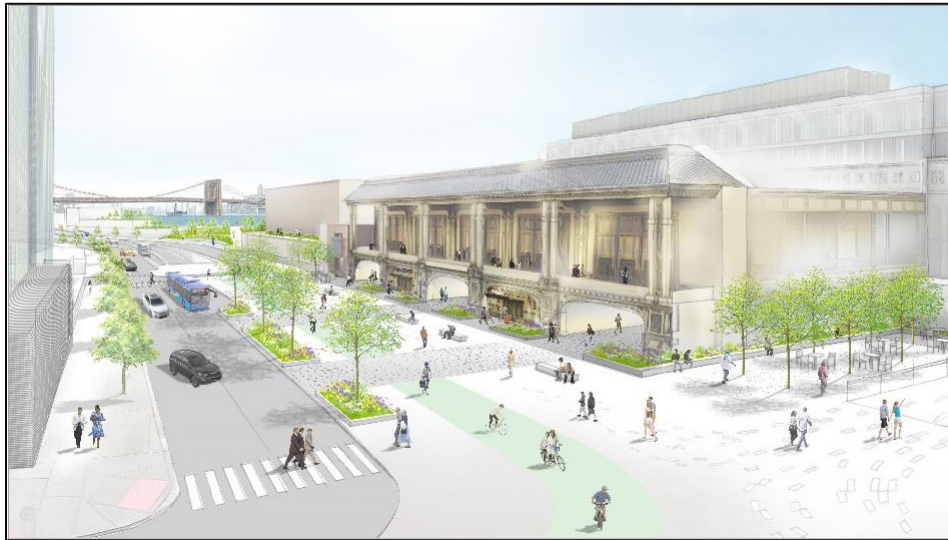
Figure 10: Streetview of the BMB (draft)
